Lookouts In The Southwestern Region

Cultural Resources Management Report No. 8

> USDA Forest Service Southwestern Region

September 1989

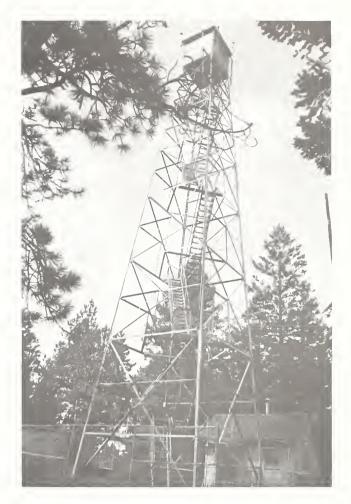
Figure 205. Wofford lookout tower, an Aermotor MC-39, and cabin on the Lincoln National Forest.

Located on the Cloudcroft Ranger District, this site (Figures 205 - 207) has a steel Aermotor MC-39 tower 80 feet high with a 7 feet square steel cab. It was erected in 1933 by the CCC.

The wood frame cabin was built in 1933 and the storage buildings in 1937. The cabin measures approximately 16 feet by 12 feet, has a simple gable roof and narrow wood slats for siding. The roof is covered with wooden shingles. The interior walls are plasterboard and the floors are hardwood. The storage shed has a simple gable wood shingled roof and measures about 7 feet by 10 feet. Both buildings rest on cement foundations.

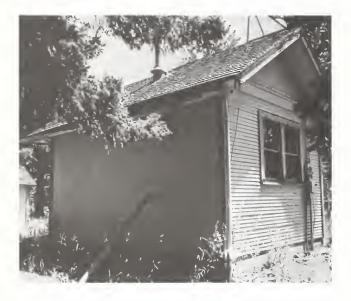
Figure 207. Wofford lookout cabin, Lincoln National Forest.

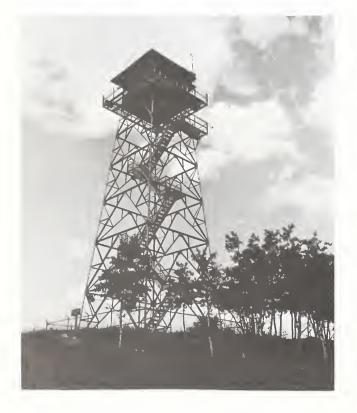
Figure 208. Sacramento lookout, a CL-100 series, built in 1968 for the Lincoln National Forest.

Located on the Cloudcroft Ranger District, this 67 feet high steel tower has a steel cab 14 feet square (Figure 208). It was erected in 1968 to replace an Aermotor LX-24 built in 1925. The present lookout is a USDA Forest Service Standard Plan CL-100 to CL-106 series type. The original tower at this location was warped by the Danley forest fire in 1967, and had to be destroyed. The present lookout is less than 50 years old, does not represent an exceptional type and is not recommended for National Register eligibility.

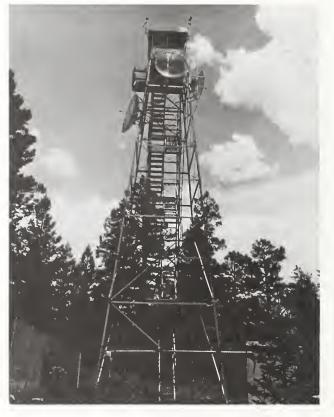
Figure 209. James Ridge lookout was moved from its original site at Mayhill.

This lookout (Figure 209) is located on the Cloudcroft Ranger District. It is a 62 feet high steel tower with a 7 feet square steel cab. It is an Aermotor LX-24 type that has been extensively remodeled. The lookout was moved to James Ridge in 1967 from its original location at the Mayhill lookout site. The lookout tower has lost its integrity of location since it was moved and it is not recommended for National Register eligibility.

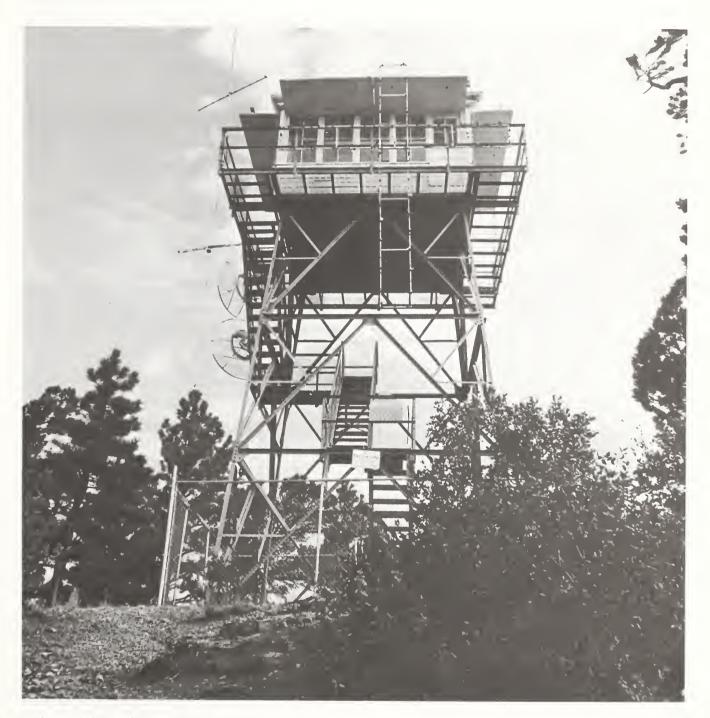
Figure 210. Ruidoso lookout has an Aermotor MI-25, one of only two of that type in the Region.

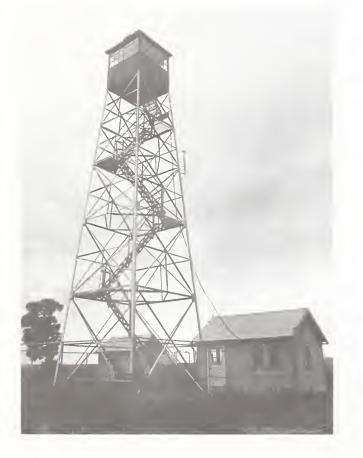
Figure 211. Bluewater lookout (either an Aermotor LX-24 or International Derrick) cabin, and storage shed.

Located on the Mayhill Ranger District, this 45 feet tall steel tower with a steel cab 7 feet square is either an Aermotor LX-24 type or an International Derrick Company tower (Figures 211 and 212). The Forest Service's records are not clear on this point. Research efforts have not been able to clarify this. It appears that while the International Derrick Company did manufacture steel towers, they did not differ much from the more common Aermotor towers. Other USFS records cited by Irwin (1986) state that this lookout tower was built in 1917 for the United States Weather Bureau and sold to the USFS for erection at this site in 1937.

Study of historic photographs suggests that no major structural modifications have occurred. Although moved from its original location, this lookout has been in place at its present location and used as a fire detection facility for 50 years. The wooden frame cabin and storage shed

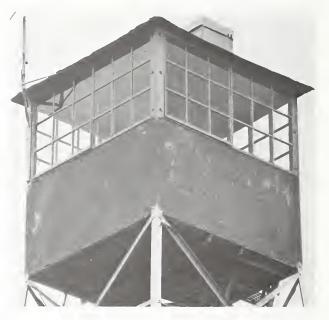
Figure 212. Bluewater lookout's cab, Lincoln National Forest.

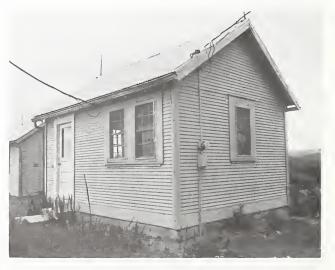
Figure 213. Bluewater lookout cabin, Lincoln National Forest.

(Figures 213 and 214) also were built at this site on 1937. They have experienced little modification outside of normal maintenance over the years.

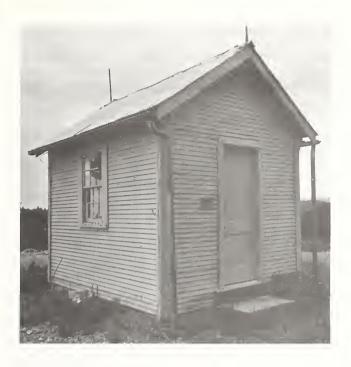
Figure 214. Bluewater lookout storage shed, Lincoln National Forest.

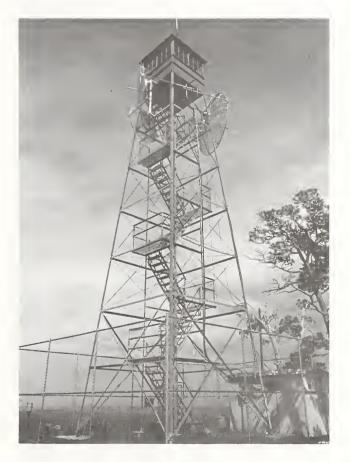
Figure 215. Weed lookout, an Aermotor LX-24, Lincoln National Forest.

This Aermotor LX-24 lookout, located on the Mayhill Ranger District, was erected in 1926. It is the oldest surviving lookout on the Lincoln National Forest. The steel tower is 48 feet high and has a steel cab 7 feet square (Figures 215 and 216). A wooden frame cabin was removed in 1978. Historic photographs indicate that no major structural changes have occurred to the tower. The wooden steps were replaced by metal ones in 1966 and a microwave dish was added for communication purposes in 1985. Otherwise, the lookout retains much of its integrity of original design, construction, location, setting, workmanship, materials and association and it is recommended for National Register eligibility.

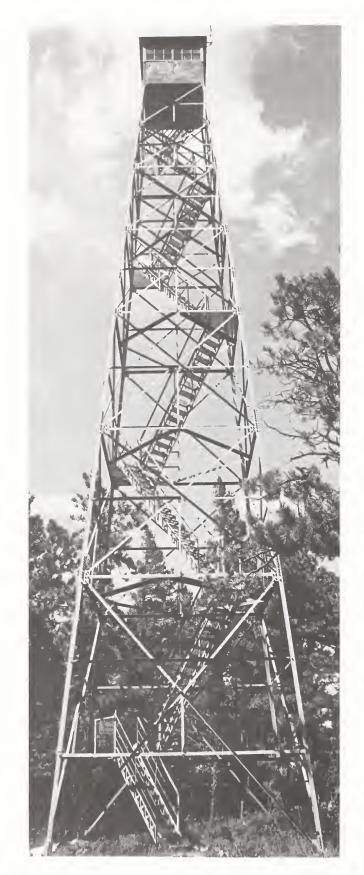
Figure 218. Carrisa lookout, an Aermotor MC-39 with an 80 feet high steel tower, built in 1934.

This Aermotor MC-39 lookout tower was erected in 1934 or 1935 and is located on the Mayhill Ranger District. It is an 80 feet high steel tower with a steel cab 7 feet square (Figures 217 and 218). This MC-39 apparently replaced earlier lookouts at this location. The wooden frame cabin with a simple gable roof (Figure 219) was built in 1935. The storage shed (Figure 220) and latrine were built in 1937. Neither of these structures show any modification from earlier photographs. The lookout tower has experienced no major structural changes.

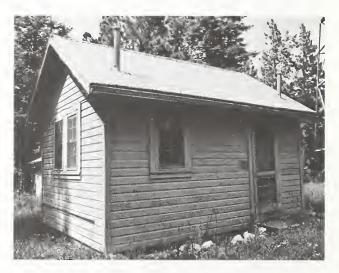
Figure 219. Carrisa lookout's wooden frame cabin is on the Mayhill Ranger District.

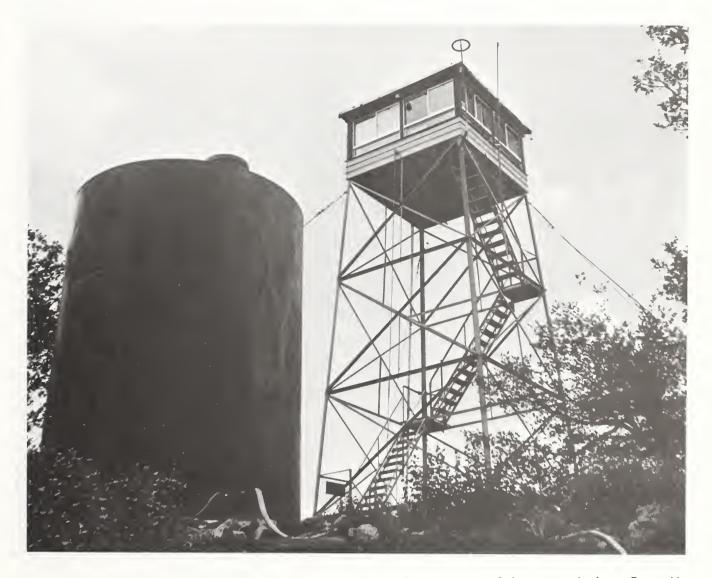
Figure 221. Horsethief lookout tower, a Pacific Coast Steel type, and its water tank on Prescott National Forest.

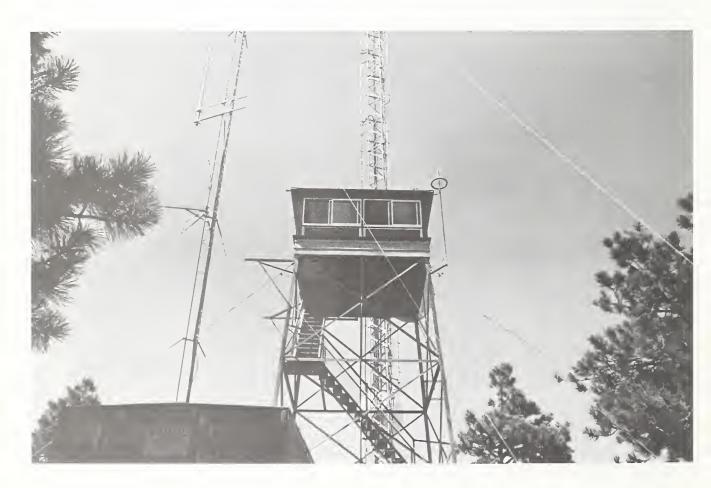
Figure 223. Towers Mountain lookout, a Pacific Coast Steel type, on the Prescott National Forest.

This lookout (Figure 223), a 30 feet high steel tower with a wooden cab 12 feet square, was also designed by the Pacific Coast Steel Company of San Francisco. It was erected at this site in 1933. A wood frame barn and cabin were built in 1928 to accompany an earlier wooden tower or lookout tree. This lookout site is located on the first (1902) ranger district in Arizona and may have served as a fire lookout point as early as 1902 or 1903.

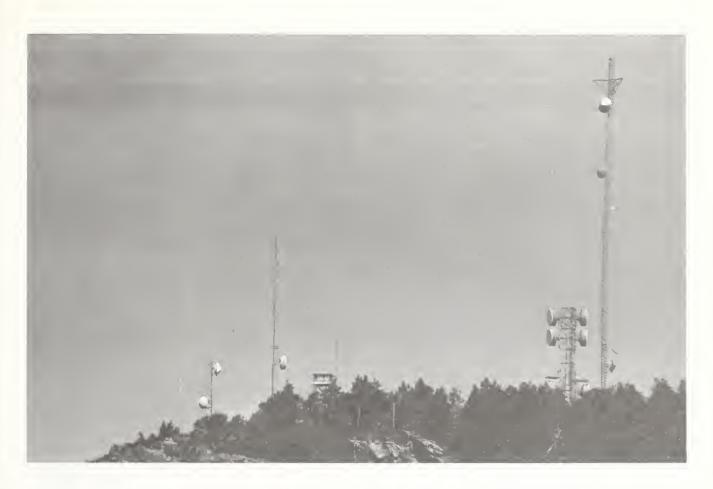
Figure 224. The Towers Mountain lookout site showing the many communications towers, Prescott National Forest.

This lookout site has been heavily disturbed by many intrusions from the construction of as many as eight microwave communication towers (Figure 224). The lookout cab has been heavily remodeled, including the addition of new windows in 1976 and 1983, new roofing in 1983 and new siding in 1984. The cabin and barn (Figures 225 and 226) have experienced little modification outside of normal maintenance.

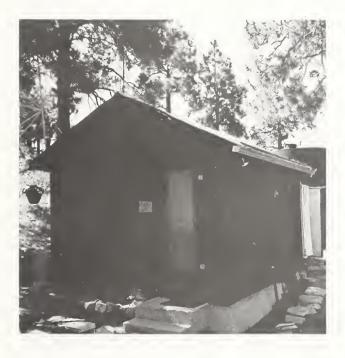
Figure 225. Towers Mountain lookout's cabin, Bradshaw Ranger District.

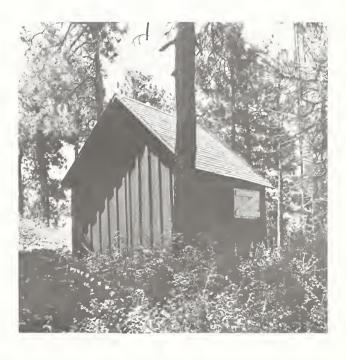
Figure 226. Towers Mountain lookout's barn, Prescott National Forest.

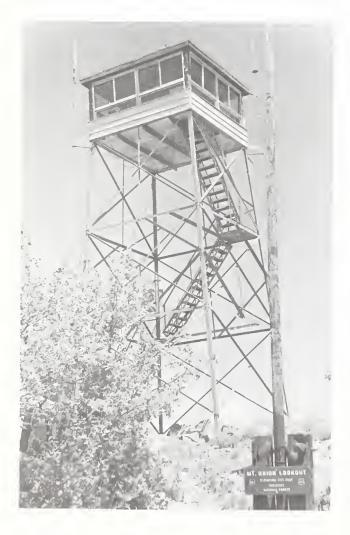
Figure 227. Mount Union lookout, an Aermotor MC-24, built in 1933 on Prescott National Forest.

Mount Union lookout is an Aermotor MC-24 and was erected in 1933 by CCC crews. This 30 feet high steel tower has a wooden cab 12 feet square. It is located on the Bradshaw Ranger District. The lookout tower (Figure 227) has experienced extensive modification including replacement of windows in 1979, new roofing in 1982, new stairs in 1983, and new siding in 1982. The lookout tower has lost its integrity of original design and construction and is not recommended for National Register eligibility.

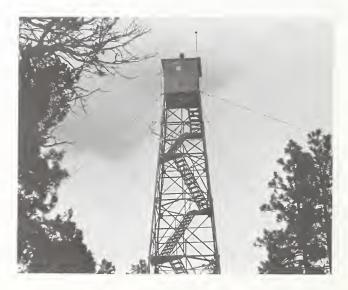
Figure 229. Mingus Mountain lookout, a Pacific Coast Steel type, on Prescott National Forest.

Located on the Bradshaw Ranger District. this 59 feet tall, steel x-brace tower has a 7 feet square steel cab. The lookout tower (Figure 229) was designed by the Pacific Coast Steel Company and was erected in 1935. The wooden frame cabin (Figure 230), a simple gable roofed structure with an overhanging front porch, was also built in 1935. Study of historic photographs indicates that no major structural changes have occurred to either the lookout tower or the cabin.

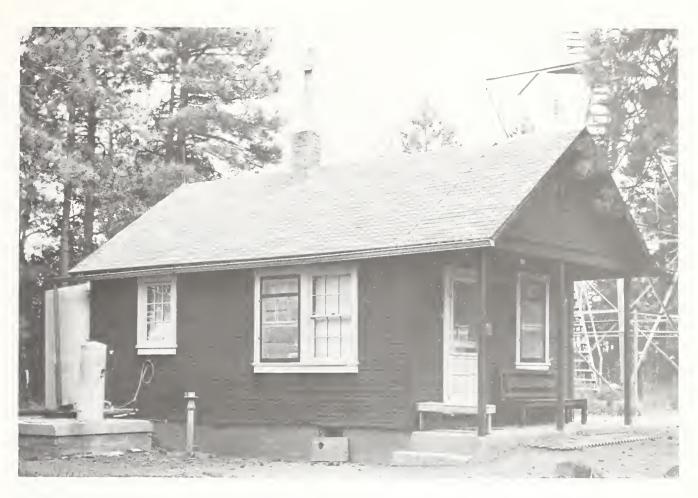
Figure 230. Mingus Mountain lookout's cabin has a floor plan of 376 square feet. A cistern is at the left rear in this view. The cabin was built in 1935.

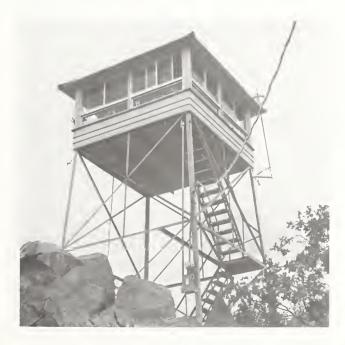
Figure 231. Spruce Mountain Lookout, an Aermotor MC-24, on Prescott National Forest.

This 30 feet high Aermotor MC-24 steel tower has a 12 feet square wooden cab (Figure 231). It was built in 1936 and is located on the Bradshaw Ranger District. It may have been erected by a CCC crew. A barn and wire corral, also built in 1936, are no longer there. This lookout tower has experienced extensive remodeling that included new windows in the period 1972 to 1981, a roof in 1974, siding in 1981, a floor in 1985 and paneling in 1980. The lookout does not retain its integrity of original design, construction, workmanship and materials. It is not recommended for National Register eligibility.

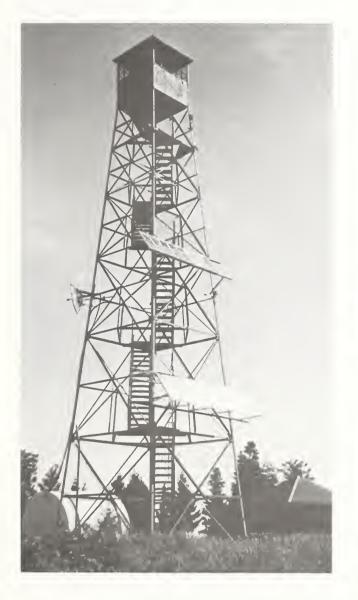
Figure 235. Encino lookout, an Aermotor MC-39, on the Santa Fe National Forest.

This 59 feet high steel Aermotor MC-39 tower has a 7 feet square steel cab (Figure 235). It is located on the Coyote Ranger District. The Encino site was constructed in July 1950 as it presently exists. Other structures include a wooden frame living quarters (Figure 236), a metal storage shed, a log cabin (Figure 237) and a wooden frame outhouse.

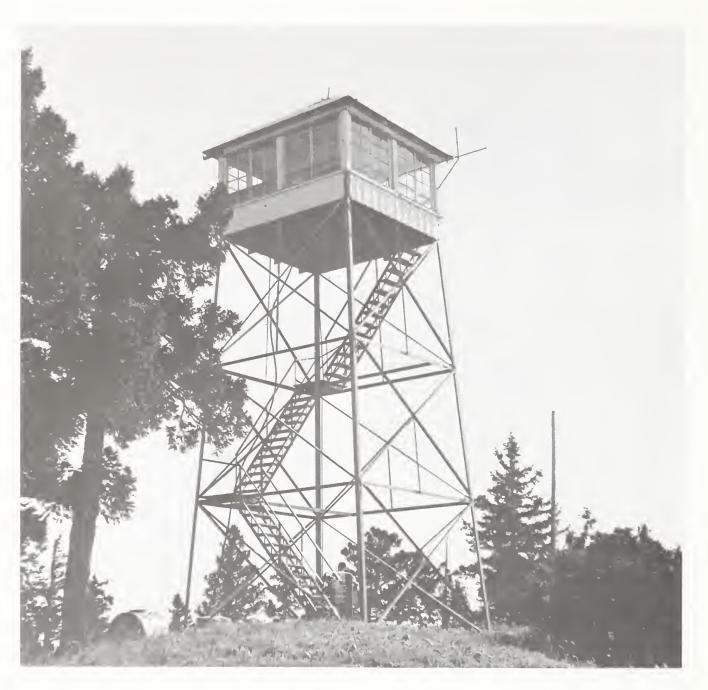
Figure 238. Glorieta Baldy lookout, an Aermotor MC-24, on the Santa Fe National Forest.

This 30 feet high steel Aermotor MC-24 tower with a wooden cab 12 feet square (Figure 238) was constructed in 1940 and is located on the Pecos Ranger District. Review of historic photographs indicates that no major structural changes have been made since the tower was built. The Glorieta Baldy lookout represents one of the best examples of an Aermotor MC-24 tower. It has retained excellent integrity of original design, construction, materials, workmanship, location and setting. It is recommended for National Register eligibility.

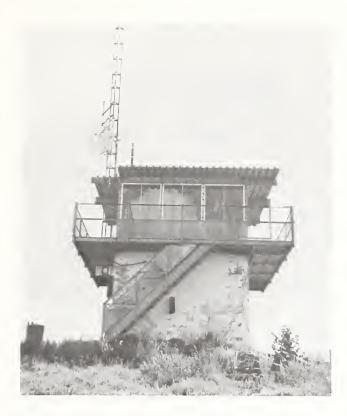
Figure 239. Cerro Pelado lookout, CL-100 series, Santa Fe National Forest.

This lookout is located on the Jemez Ranger District and was constructed in 1965. It has a 14 feet square steel cab on a 10 feet high cement blockhouse base (Figure 239). The lookout is a USDA Forest Service Standard Plan CL-100 to CL-106 series type. It replaced an earlier L-4 lookout house constructed in 1932. The L-4 had

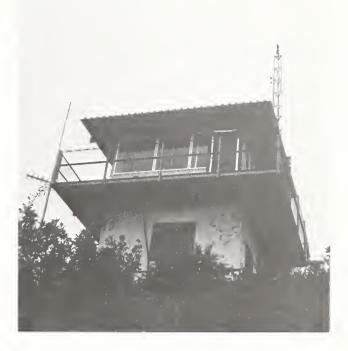
Figure 240. Dome lookout (CL-100 series), Santa Fe National Forest.

located on the Jemez Ranger District and was erected in 1965 to replace an earlier wood frame lookout house (L-4 type) built in the 1930s. The present lookout (Figure 240) consists of a 14 feet square metal cab on a 10 feet high cement block house base. This lookout location was previously known as St. Peter's Dome. The present lookout structure is less than 50 years of age, does not represent an exceptional type and is not recommended for National Register eligibility.

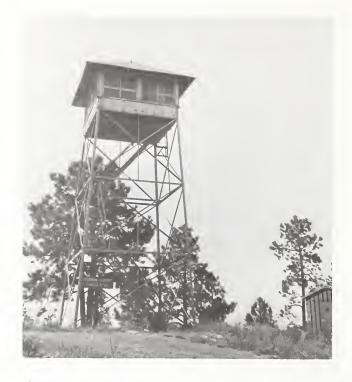
Figure 241. Deadman lookout, an Aermotor MC-24, on the Santa Fe National Forest.

This site has a 30 feet high steel Aermotor MC-24 with a wooden cab 12 feet square (Figure 241). It was erected in 1933 and is located on the Cuba Ranger District. It replaced an earlier wooden platform tower built in the 1920s. The lookout roof has been modified and the original nine-pane windows were replaced with sliding aluminum windows in 1969. This lookout, although meeting the age requirements, has lost its integrity of original design, construction, workmanship and materials and is not recommended for National Register eligibility.

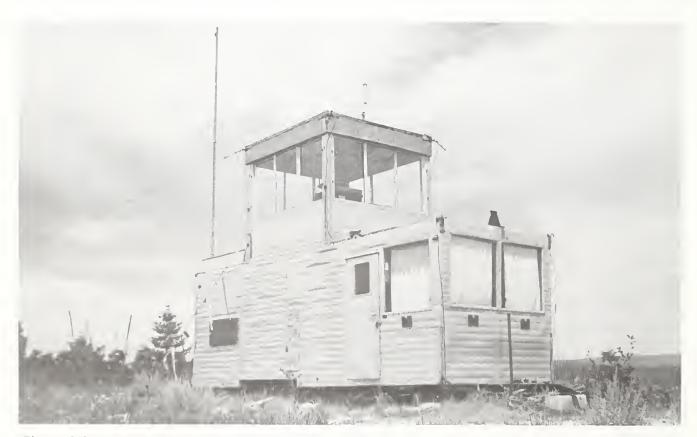
Figure 242. A portable lookout (trailer) now located at Red Top lookout on the Santa Fe National Forest. This is the only trailer in use as a lookout in the Southwestern Region.

Located on the Cuba Ranger District, the Red Top Lookout (Figure 242) is the only trailer lookout presently in use on the Santa Fe National Forest. The date at which the lookout trailer was placed at the site is unknown. It apparently replaced (sometime in the 1960s) a 14 feet square wood frame, L-4 type, lookout house built in 1933. This trailer lookout is not recommended for National Register eligibility.

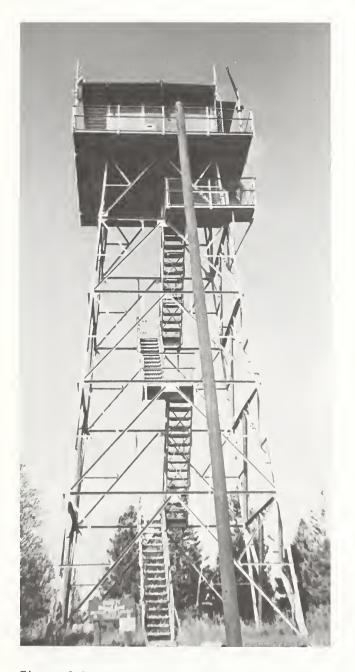
Figure 243. Barrillas lookout (CL-100 series), Santa Fe National Forest.

This 54 feet high steel tower with a 14 feet square steel cab is located on the Pecos Ranger District and was constructed in 1959. This lookout (Figure 243) represents another USDA Forest Service Standard Plan CL-100 to CL-106 series type. It apparently replaced an earlier Aermotor steel tower erected in the 1930s. This lookout is less than 50 years old, does not represent an exceptional type and is not recommended for National Register eligibility.

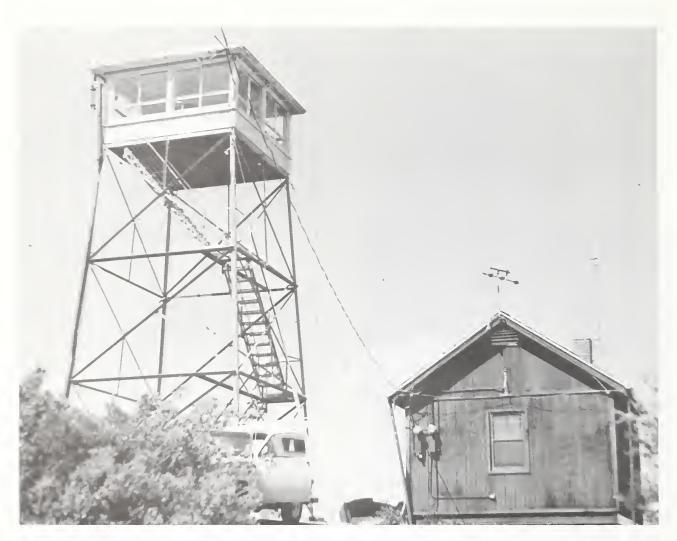
Figure 244. The Diamond Point lookout, an Aermotor MC-24, and cabin on the Tonto National Forest.

This steel Aermotor MC-24 tower is 30 feet high with a 12 feet square cab (Figure 244). It is located on the Payson Ranger District and was erected in the fall of 1936, probably by a CCC crew. The lookout tower has been modified. Metal steps were added in 1984 and, at an unknown date, the original windows were replaced with sliding aluminum windows and the wooden shutters were removed. The lookout tower has lost its integrity of original design and construction and is not recommended for National Register eligibility.

The wooden frame cabin with a simple gable roof and shiplap siding is little changed from when it was built in 1941. A garage barn also built at the site in 1941 was destroyed in 1972. The wood frame cabin has retained its integrity of original design, construction, workmanship and materials and is recommended for National Register eligibility.

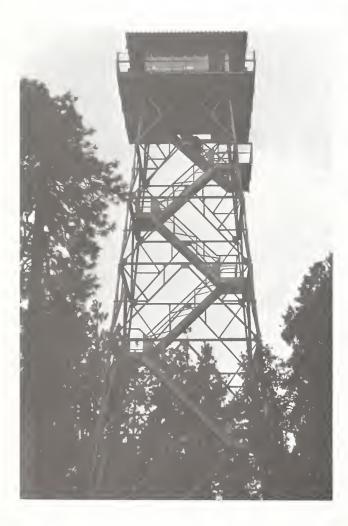
This lookout (Figure 247) is a USDA Forest Service Standard Plan CL-100 to CL-106 series type. It was erected by Cline Construction Company of Globe, Arizona in 1964. The 14 feet square steel cab sits on a 10 feet high concrete blockhouse base. The lookout is located on the Pleasant Valley Ranger District. This lookout replaced an earlier 20 feet high Aermotor tower with a metal cab 7 feet square built in 1927. A cabin, barn and shed built in the early 1930s were razed in 1964. This lookout, less than 50 years old, does not represent an exceptional type and is not recommended for National Register eligibility.

Figure 247. McFadden Peak lookout was erected in 1964 on the Tonto National Forest.

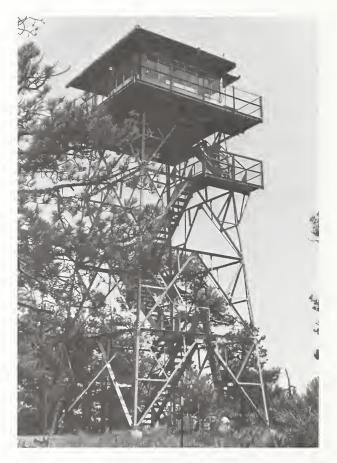
This lookout (Figure 248) was erected by Cline Construction of Globe, Arizona, in 1960 and is located on the Pleasant Valley Ranger District. It is another example of a USDA Forest Service Standard Plan CL-100 to CL-106 series type also known as an R-6 flat. This lookout tower has a 14 feet square steel cab on a steel tower 83 feet tall.

The present lookout replaced a 50 feet high Aermotor LX-24 tower with a 7 feet square steel cab built in 1925. A second 35 feet high steel Aermotor LX-24 tower was built in 1928 at this site. Apparently the two Aermotor towers were operated at the same time. A cabin associated with these earlier towers has been removed.

Figure 248. Colcord lookout, another CL-100 series, on the Tonto National Forest.

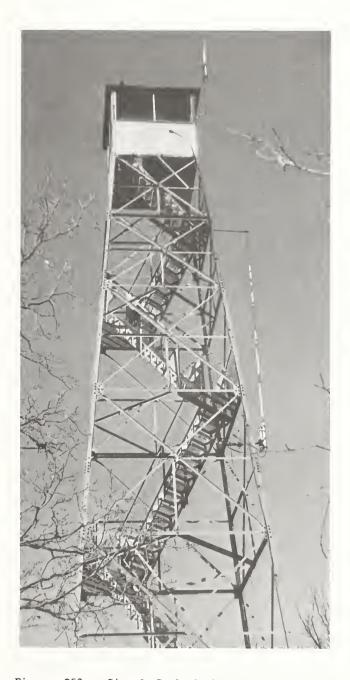
This lookout (Figure 249), located on the Pleasant Valley Ranger District, was erected in 1956. It represents another USDA Forest Service Standard Plan CL-100 to CL-106 series type. The lookout has a 12 feet square steel cab on a steel tower 41 feet high. This lookout replaced a D-6 cupola style lookout house built in 1925. This lookout is less than 50 years old, does not represent an exceptional type and is not recommended for National Register eligibility.

Figure 249. Aztec Peak lookout is on the Tonto's Pleasant Valley Ranger District.
